PERATION

GREENHOUSE

SCIENTIFIC DIRECTOR'S REPORT

ANNEX 3.2 U. S. NAVY STRUCTURES

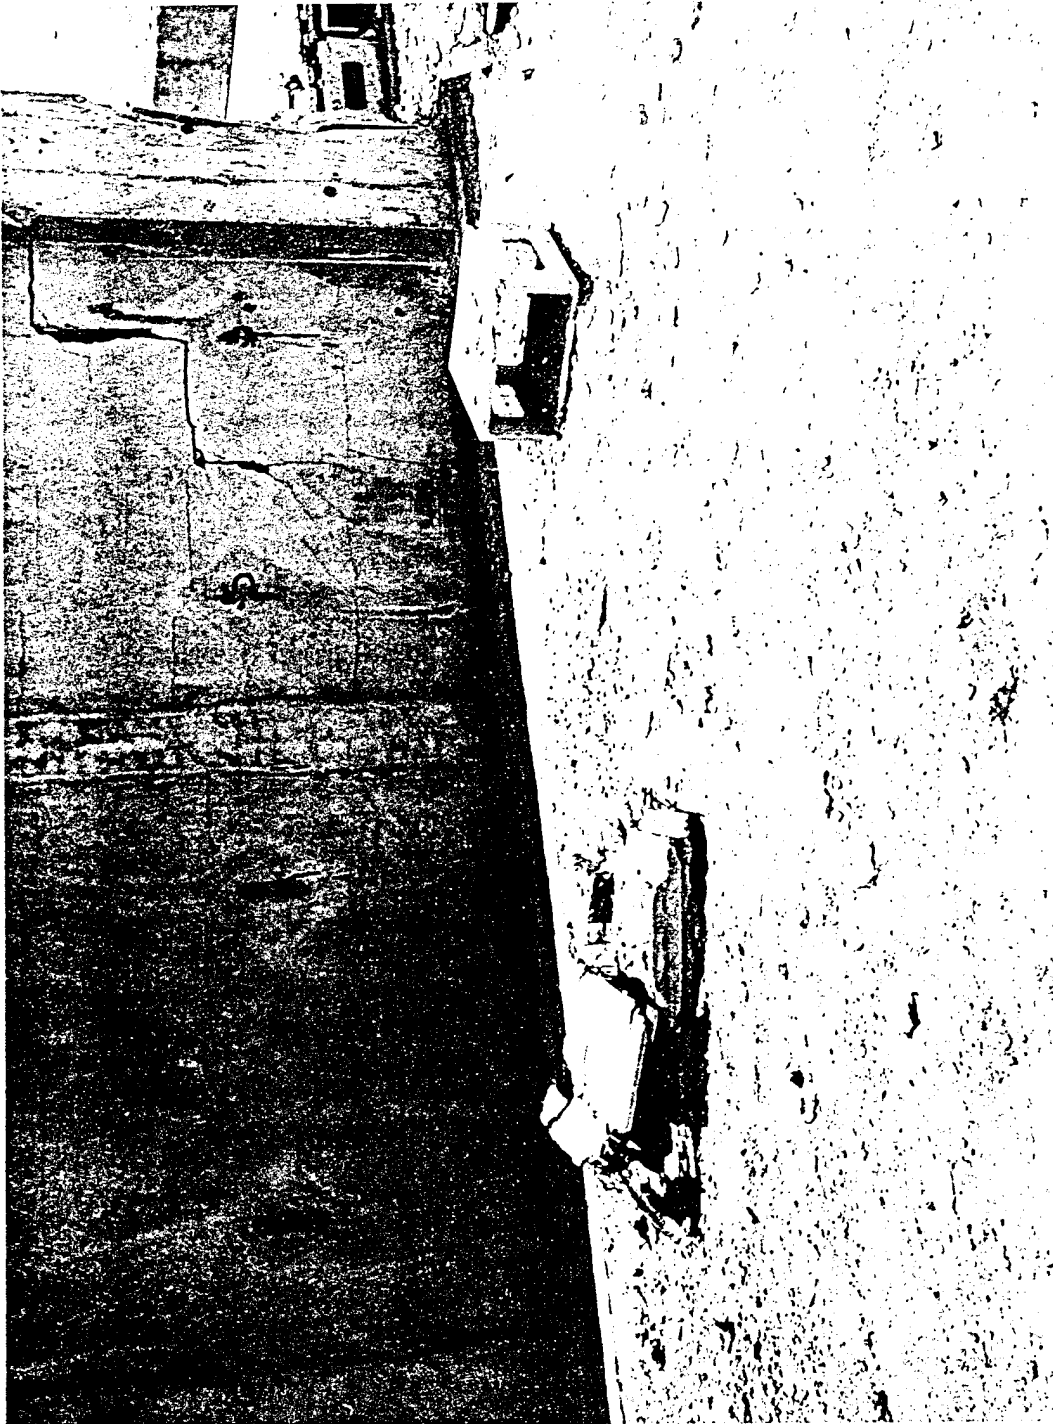
Fig. L.241 Detail View of Base of Rear Wall, Showing Cracks at Foundation Line and Fine Horizontal Cracks
Between Cells in the Panels, Structure 3.2.3b

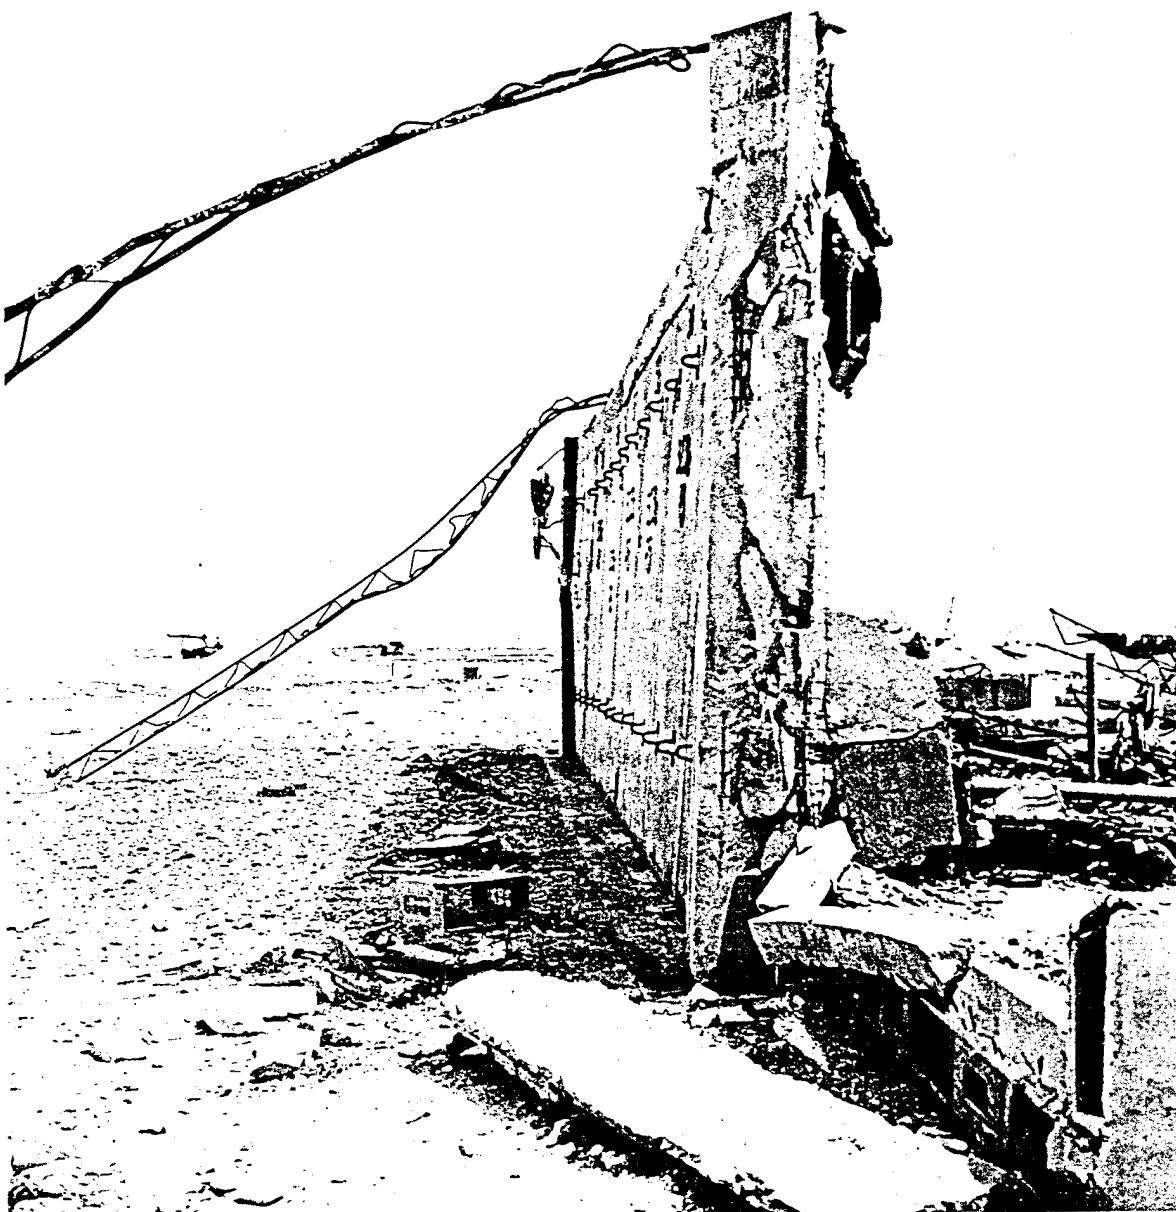
Fig. L.243 Detail View of Cracks in Rear-wall Panel Adjacent to Pilaster, Structure 3.2.3b

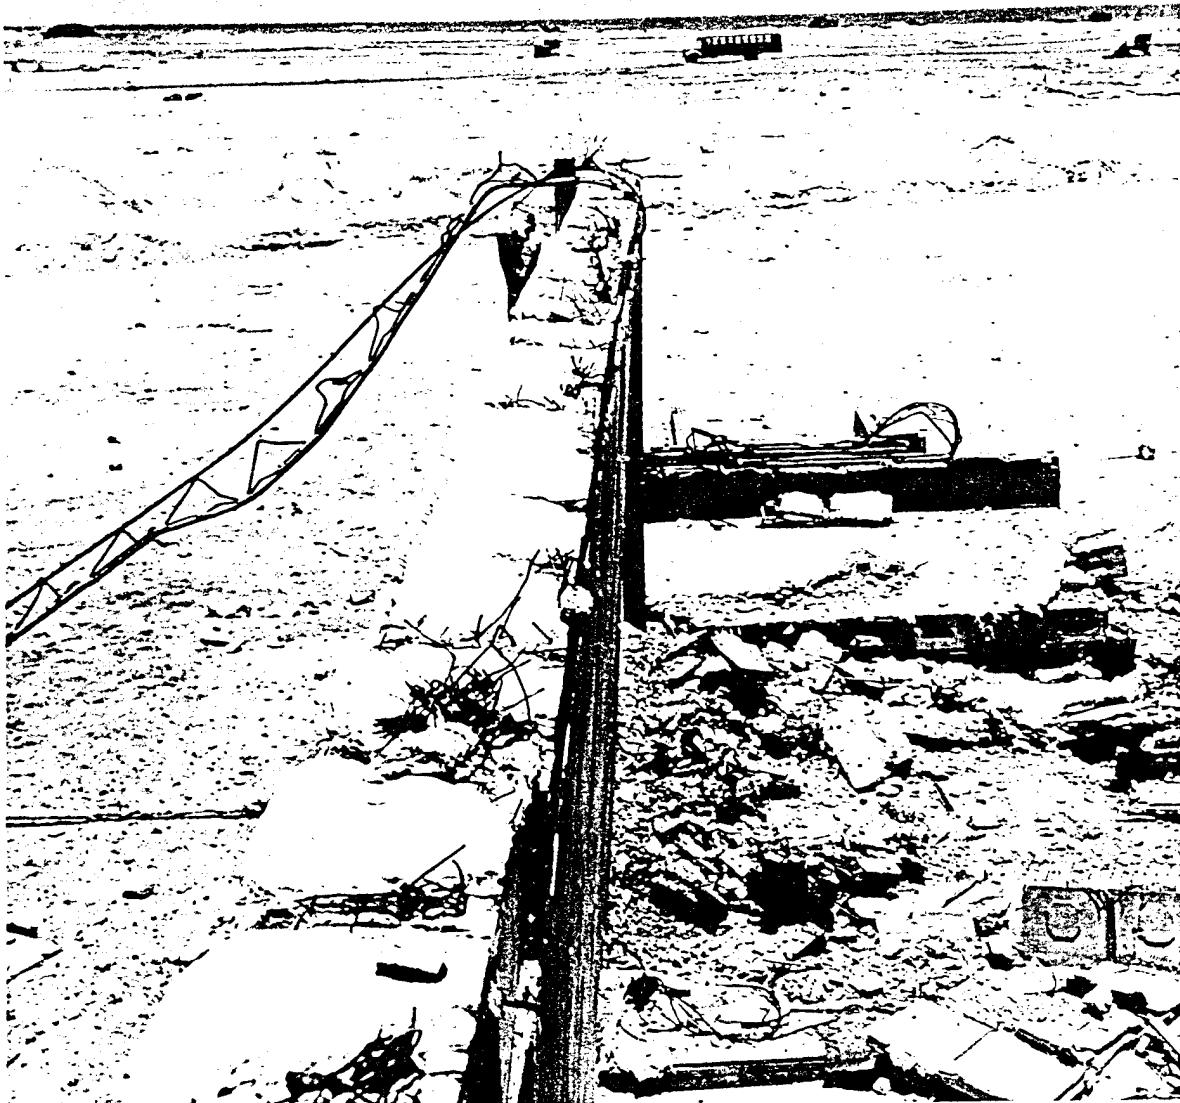
Fig. L. 245 Detail View of Pilaster at Left Rear Corner, Showing Where End Wall Forced Pilaster to Split Open, Structure 3.2.3b.

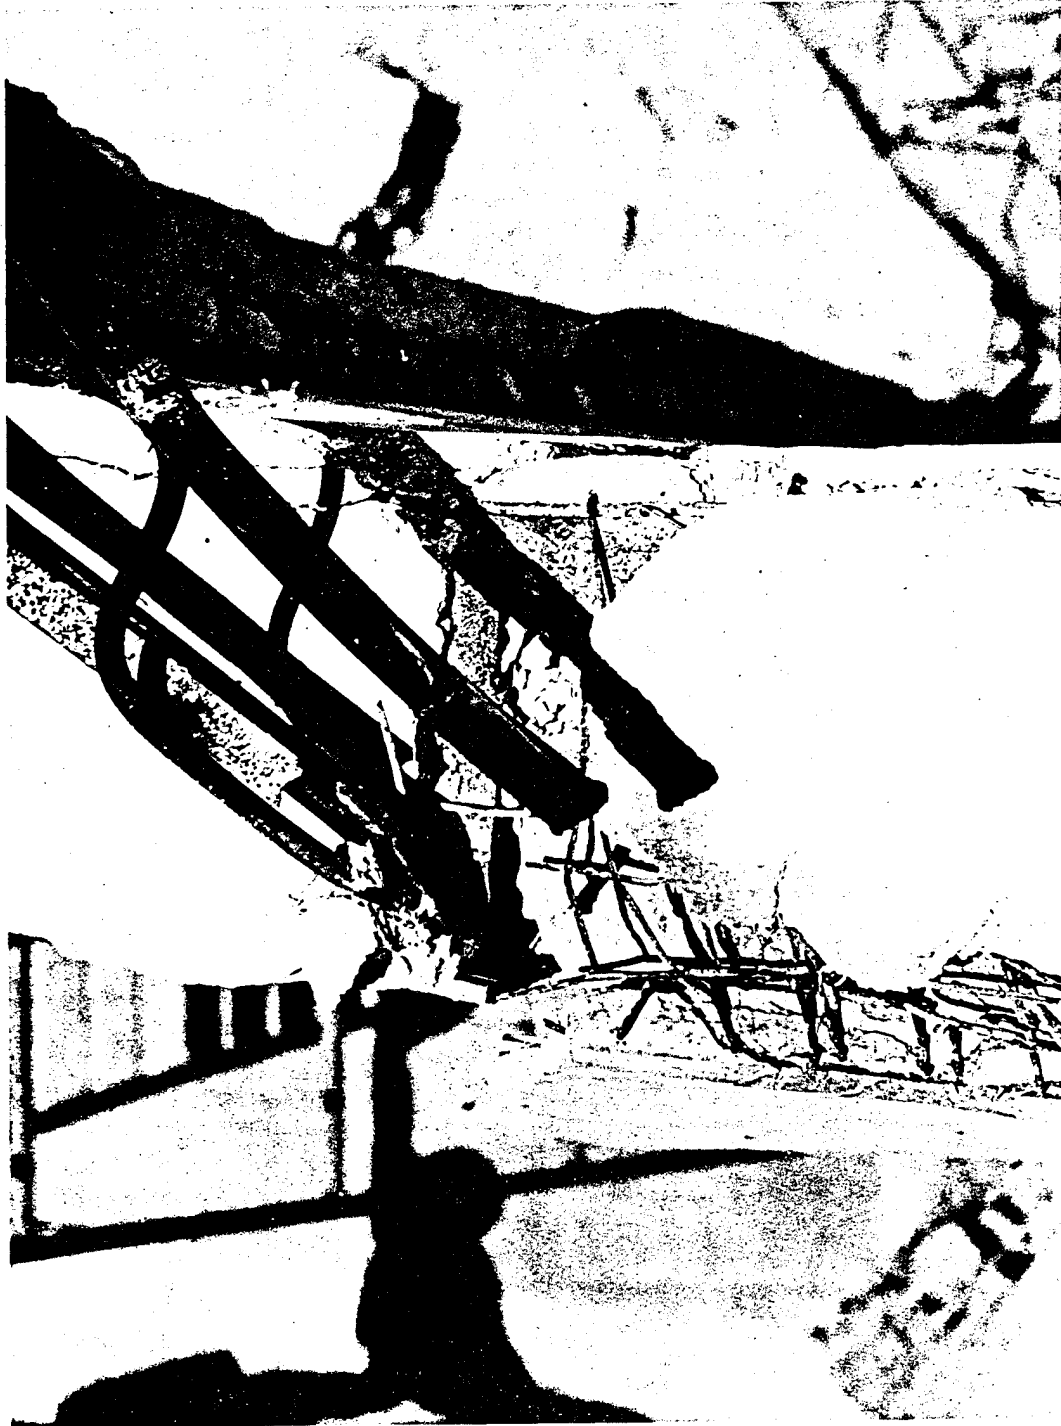
Fig. L. 246 General View along Top of Rear Wall, Taken from Left End, Structure 3.2.3b

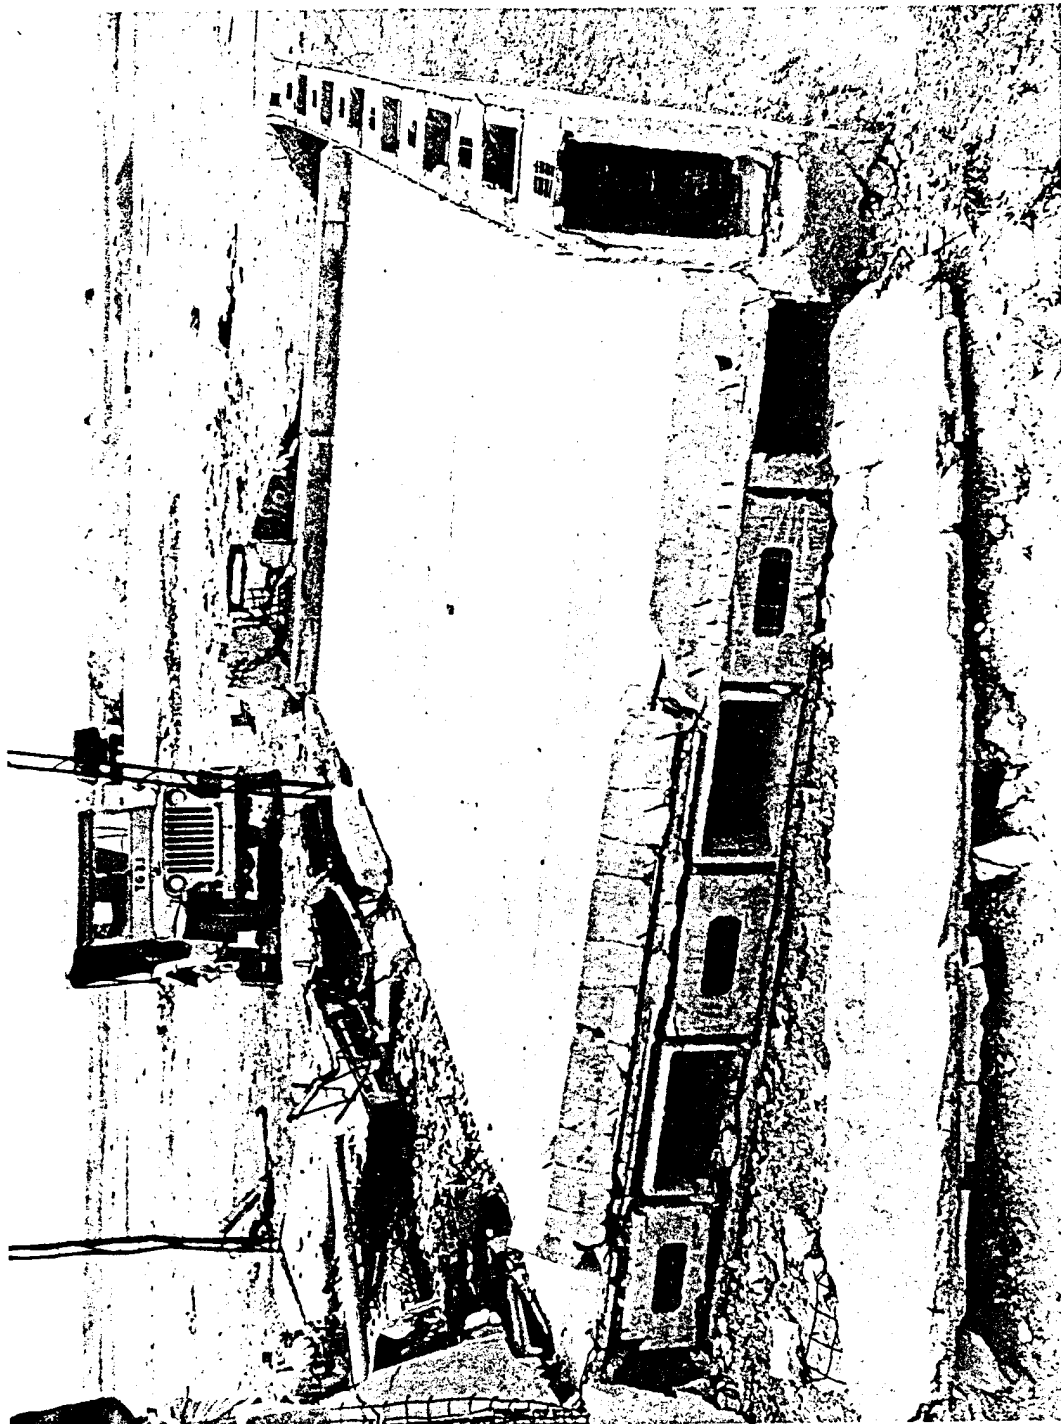
Fig. L. 248 Detail View Showing Where Roof Truss Broke Loose from Truss End Through Weld, Structure 3. 2. 3b

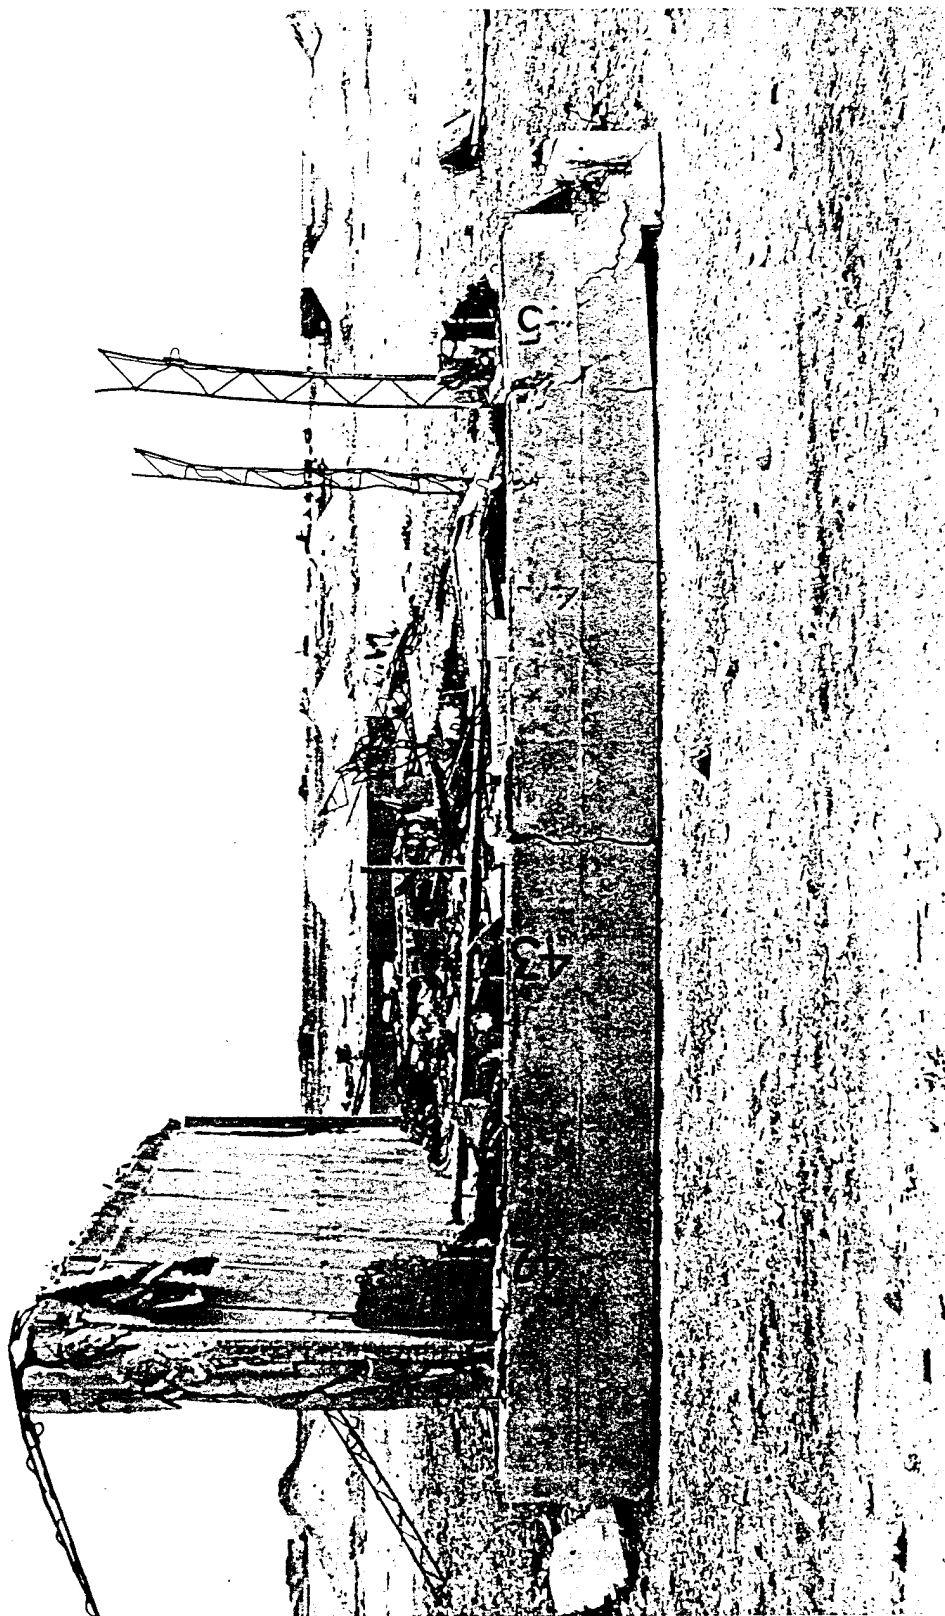
Fig. L. 249 Rear Edge of Left End Wall, Structure 3.2.3b

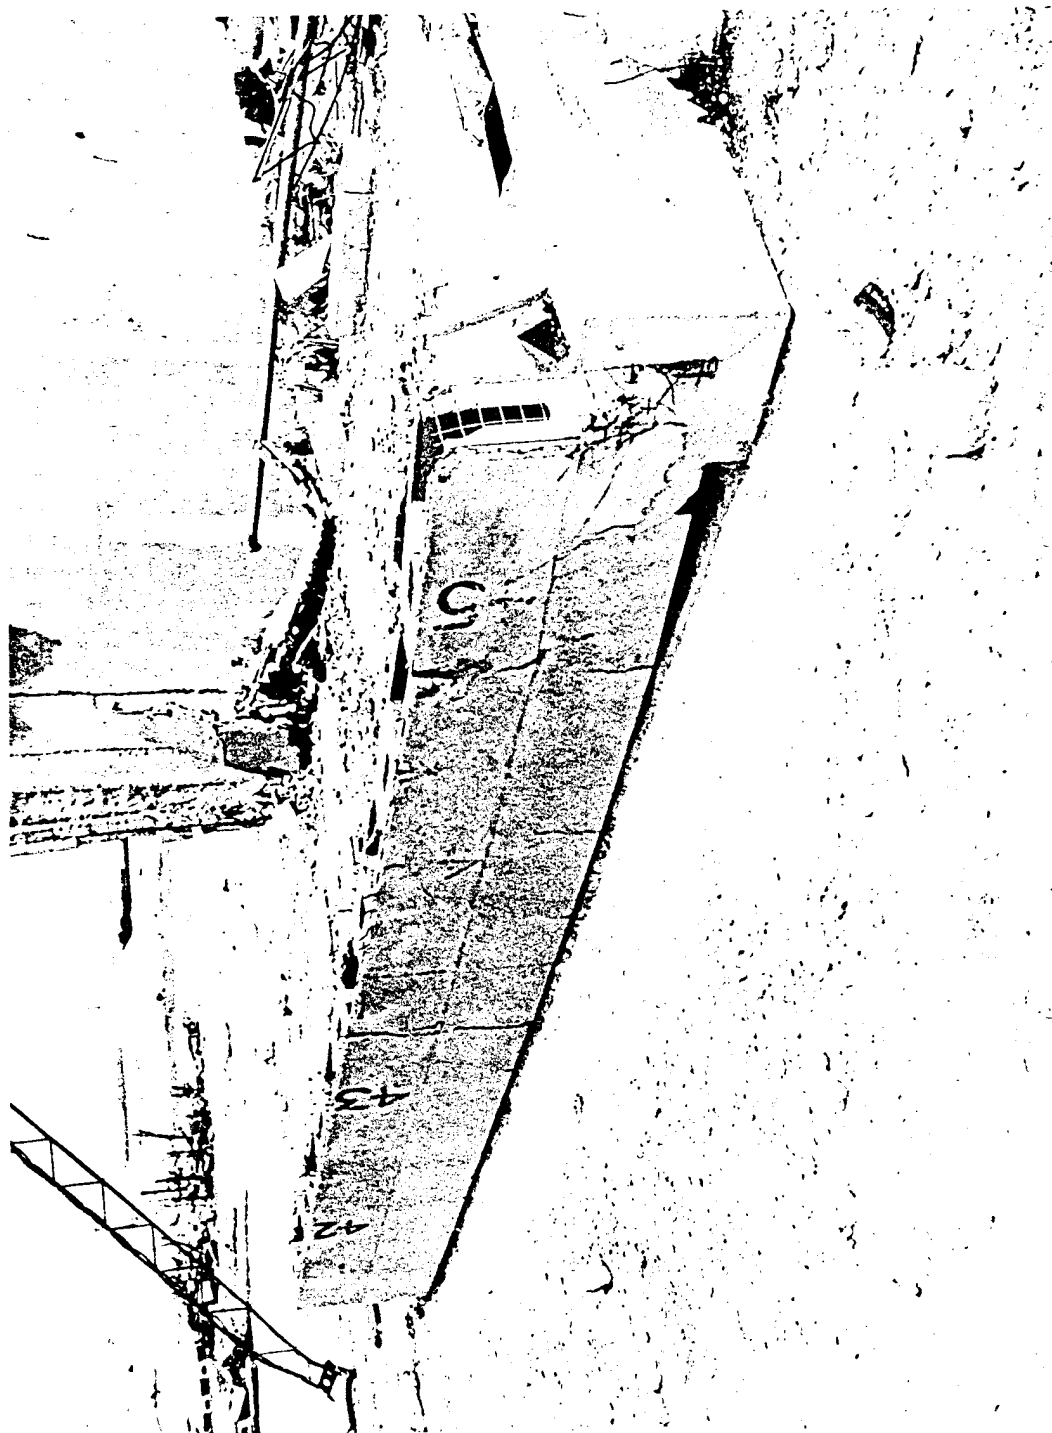
Fig. L. 250 Top Edge of Left End Wall, with Left Edge Row of Roof Cells Attached, Structure 3.2.3b

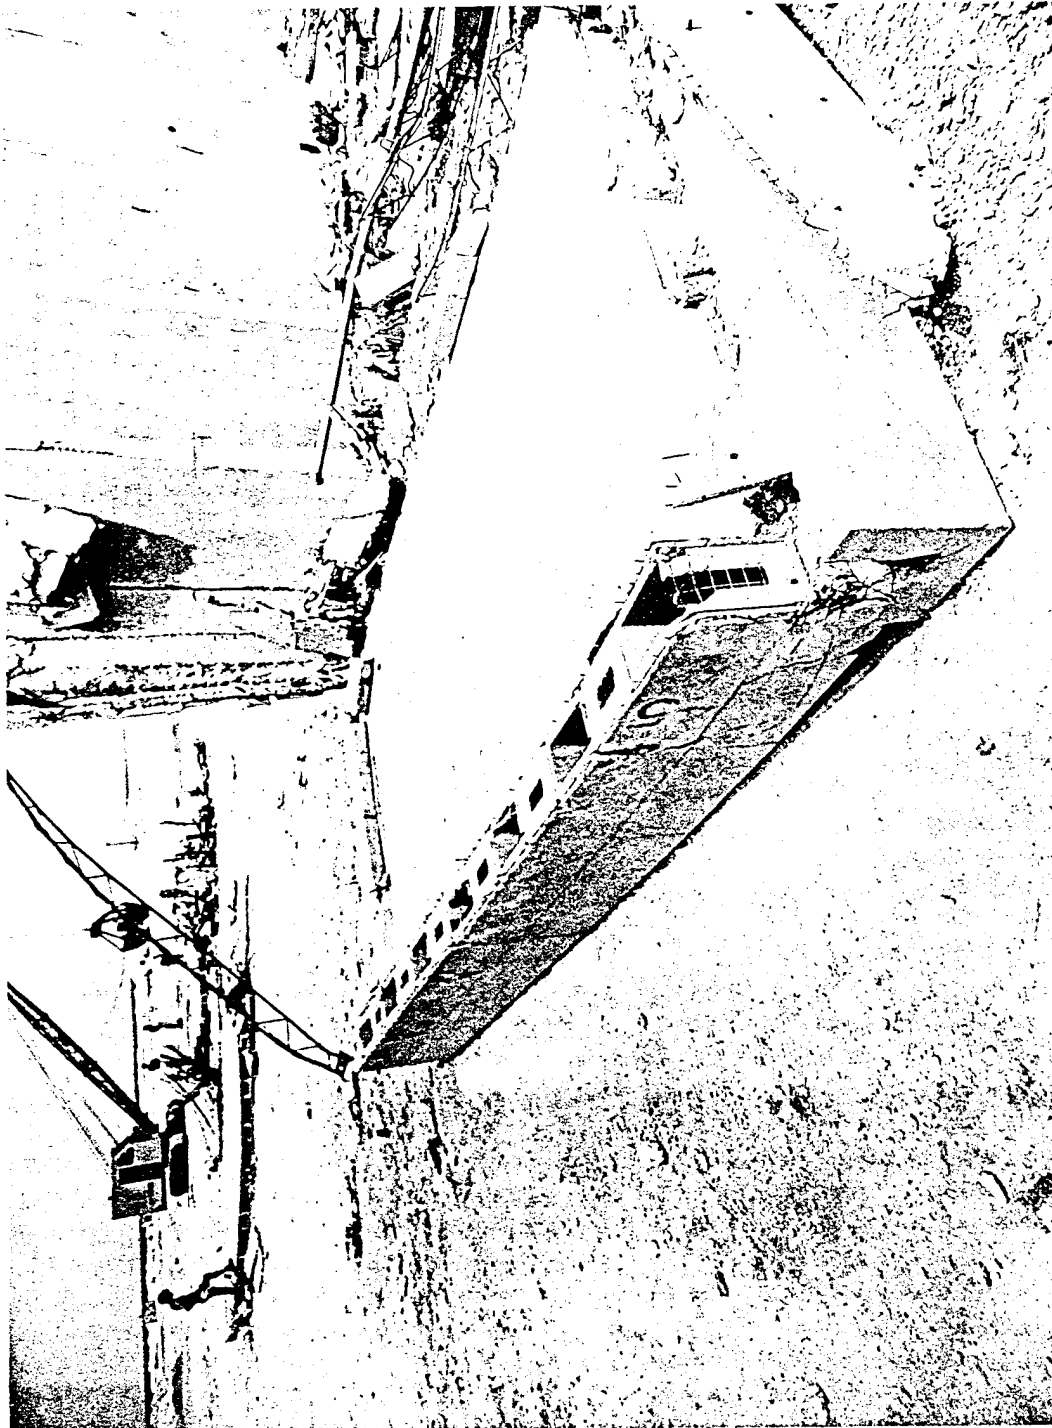
Fig. L.251 View of Top Edge of Left End Wall, Showing Slight Bending and Crack Caused by Projection on
Pilaster during Landing, Structure 3.2.3b

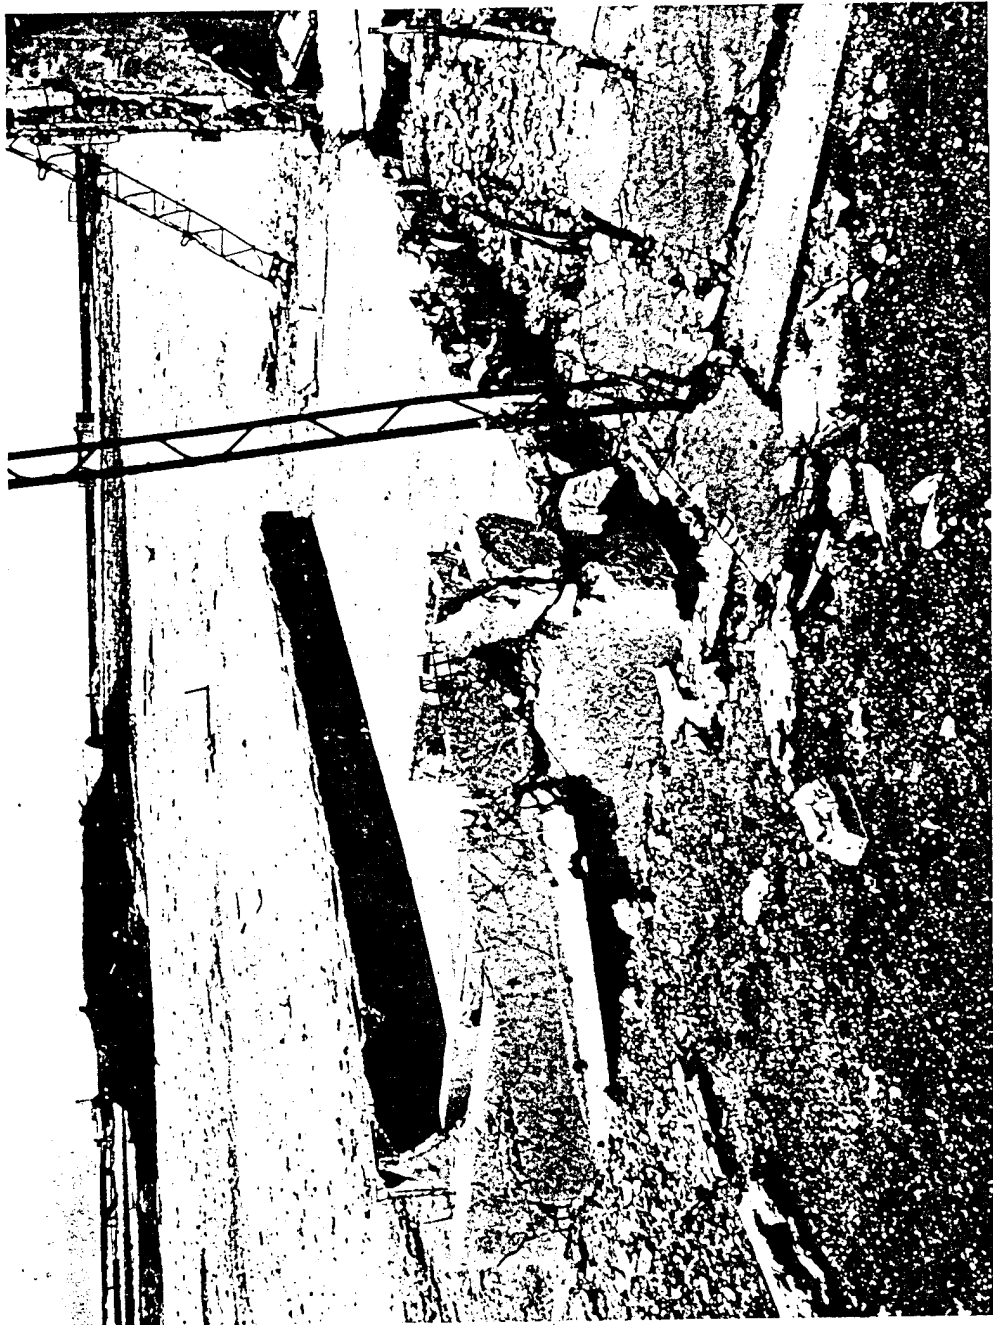
Fig. L.252 View along Plane where Main Section of Roof Was Severed from End-wall Unit, Structure 3.2.3b.
Note the clean cleavage.

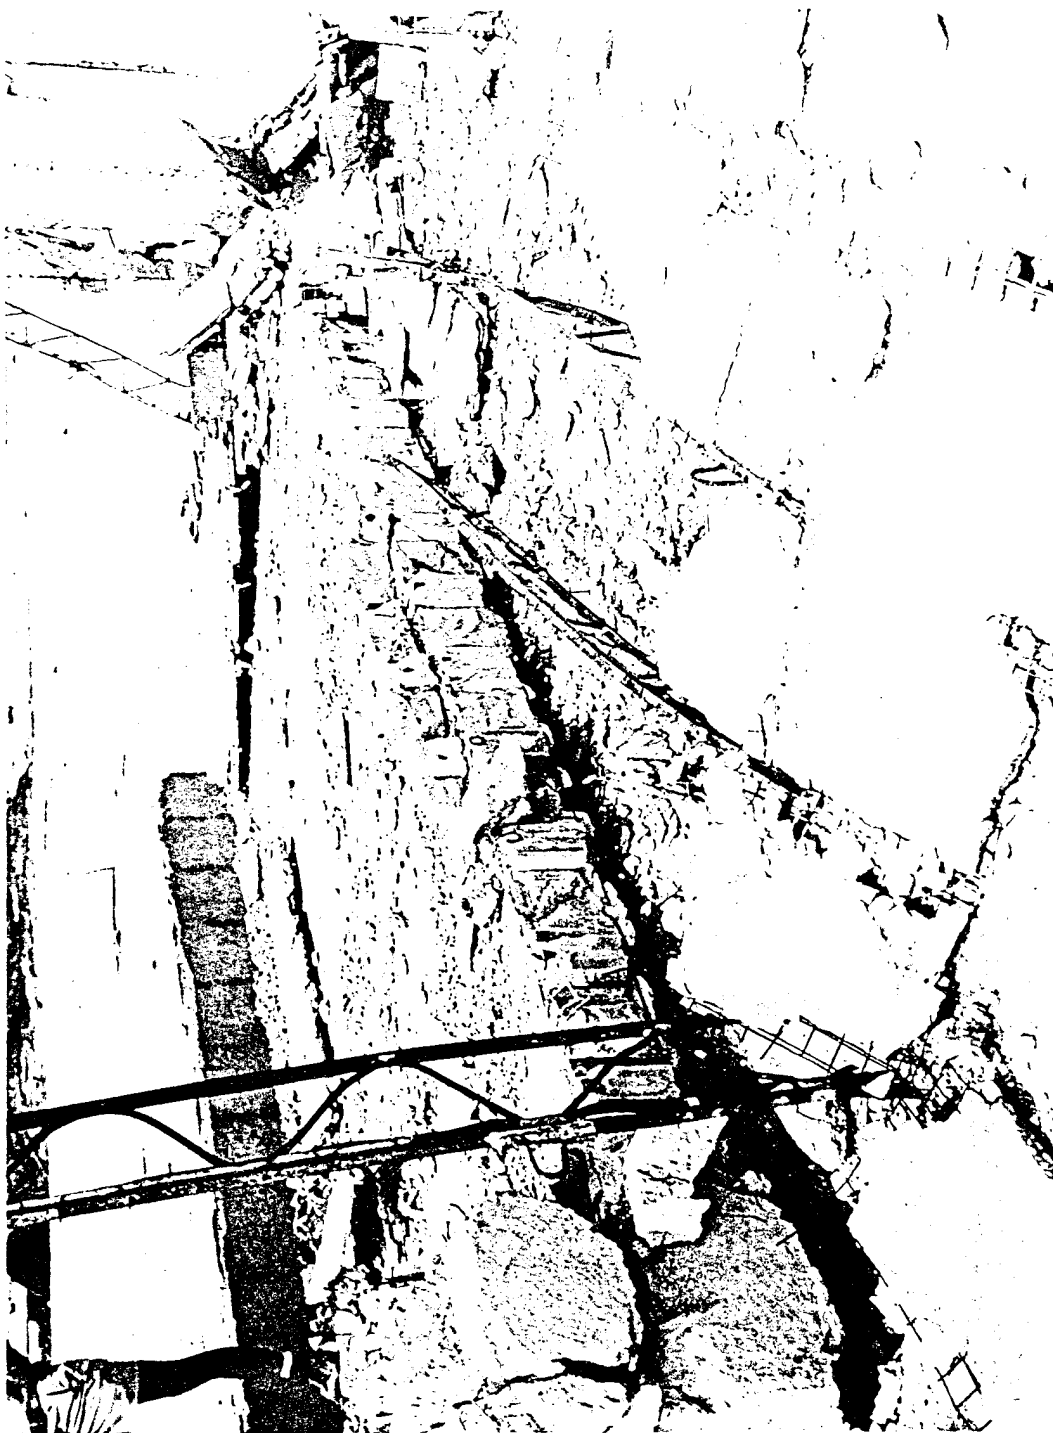
Fig. L. 253 View of Inside Face of Left End Wall, Structure 3.2.3b

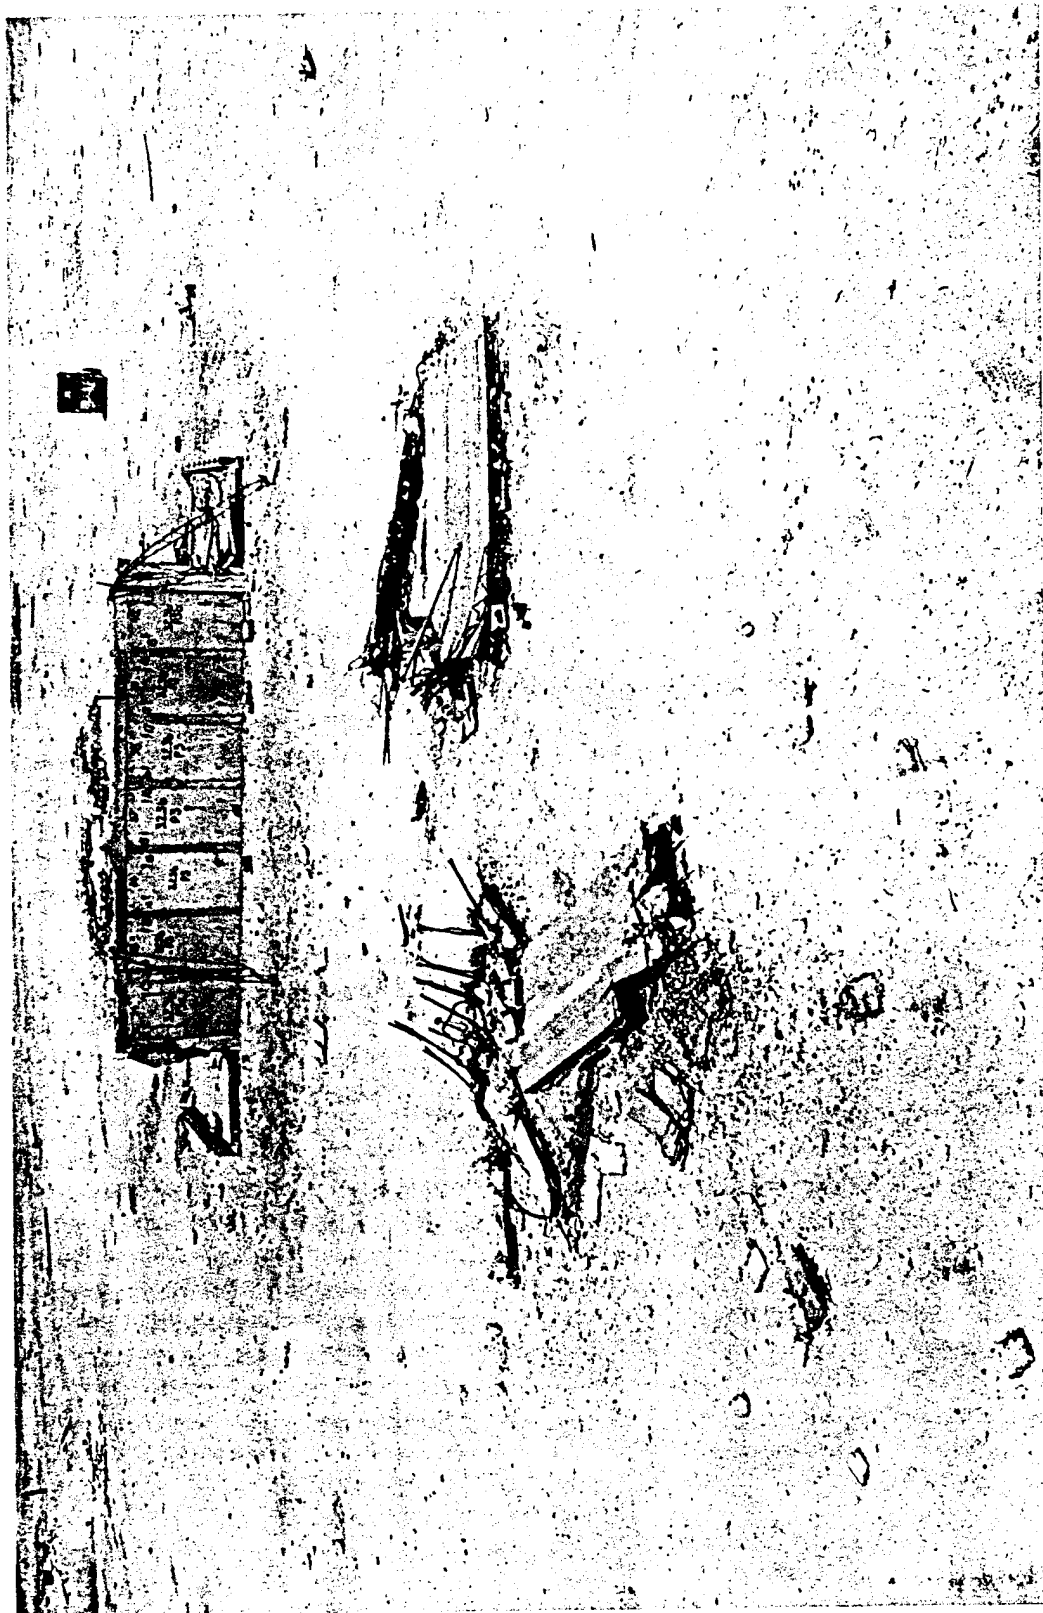
Fig. L. 254 General View of Base of Left End Wall, Structure 3. 2. 3b. In all cases the trusses pulled loose from the channel sections used for anchorage.

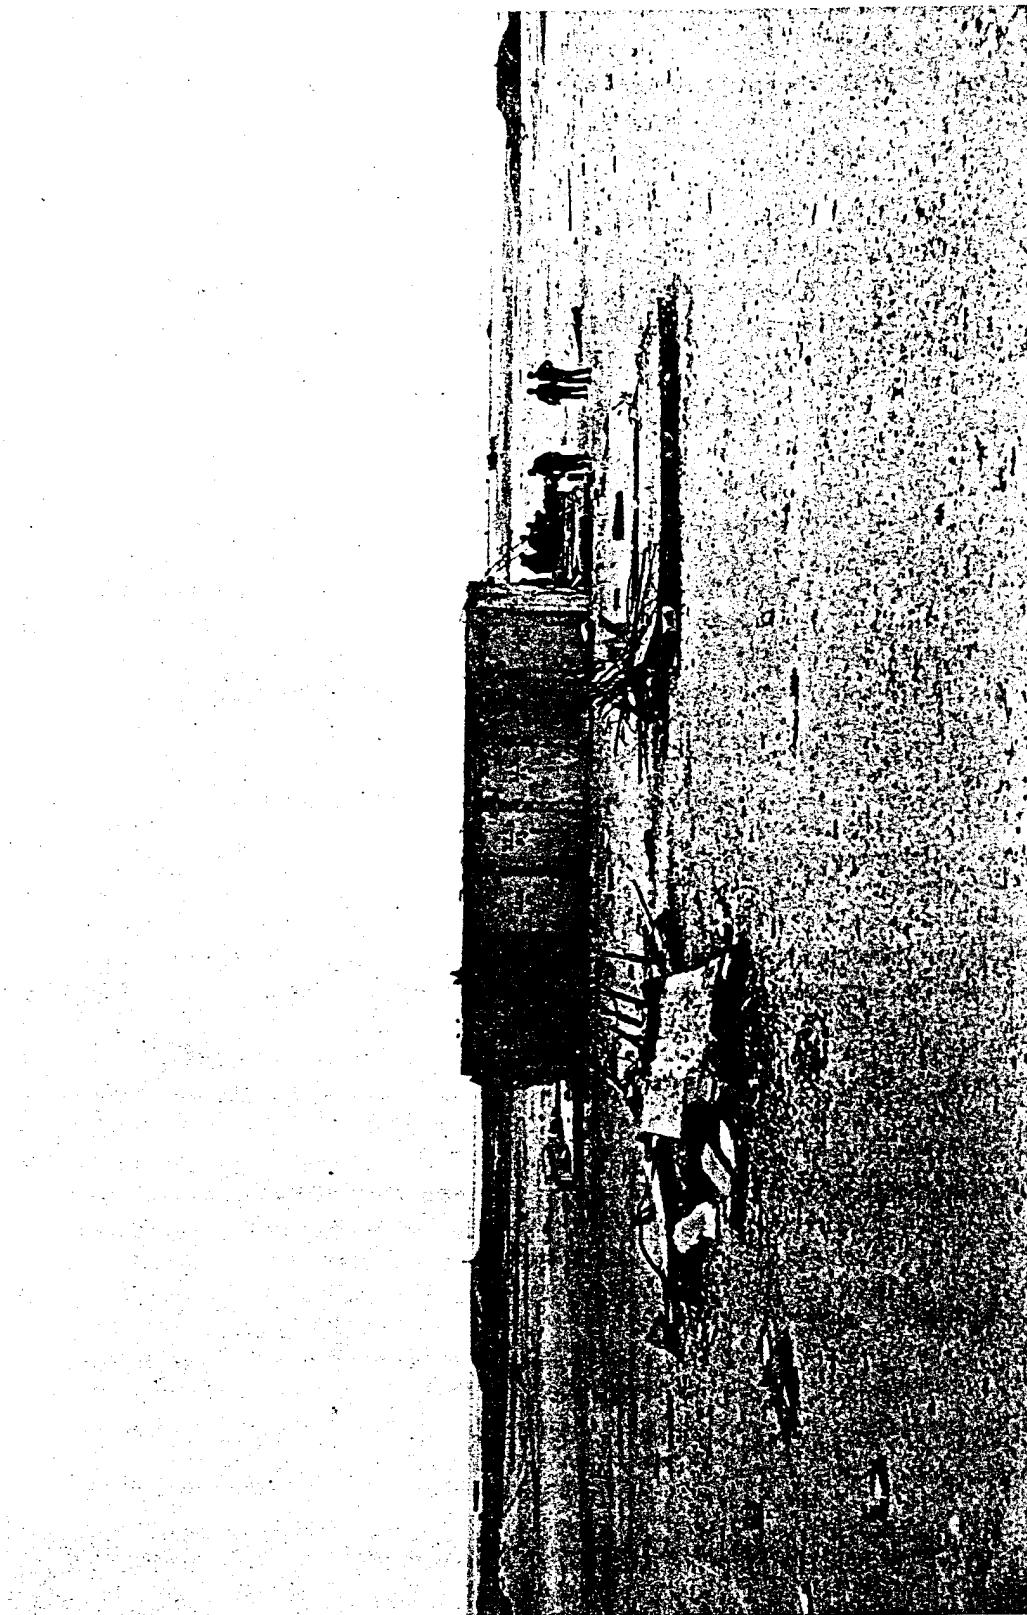
Fig. L. 255 General View of Roof Sections, Taken from Rear, Structure 3.2.3b. Large section in the left center of photograph is the right half of roof, and section in right center is the left half of roof.

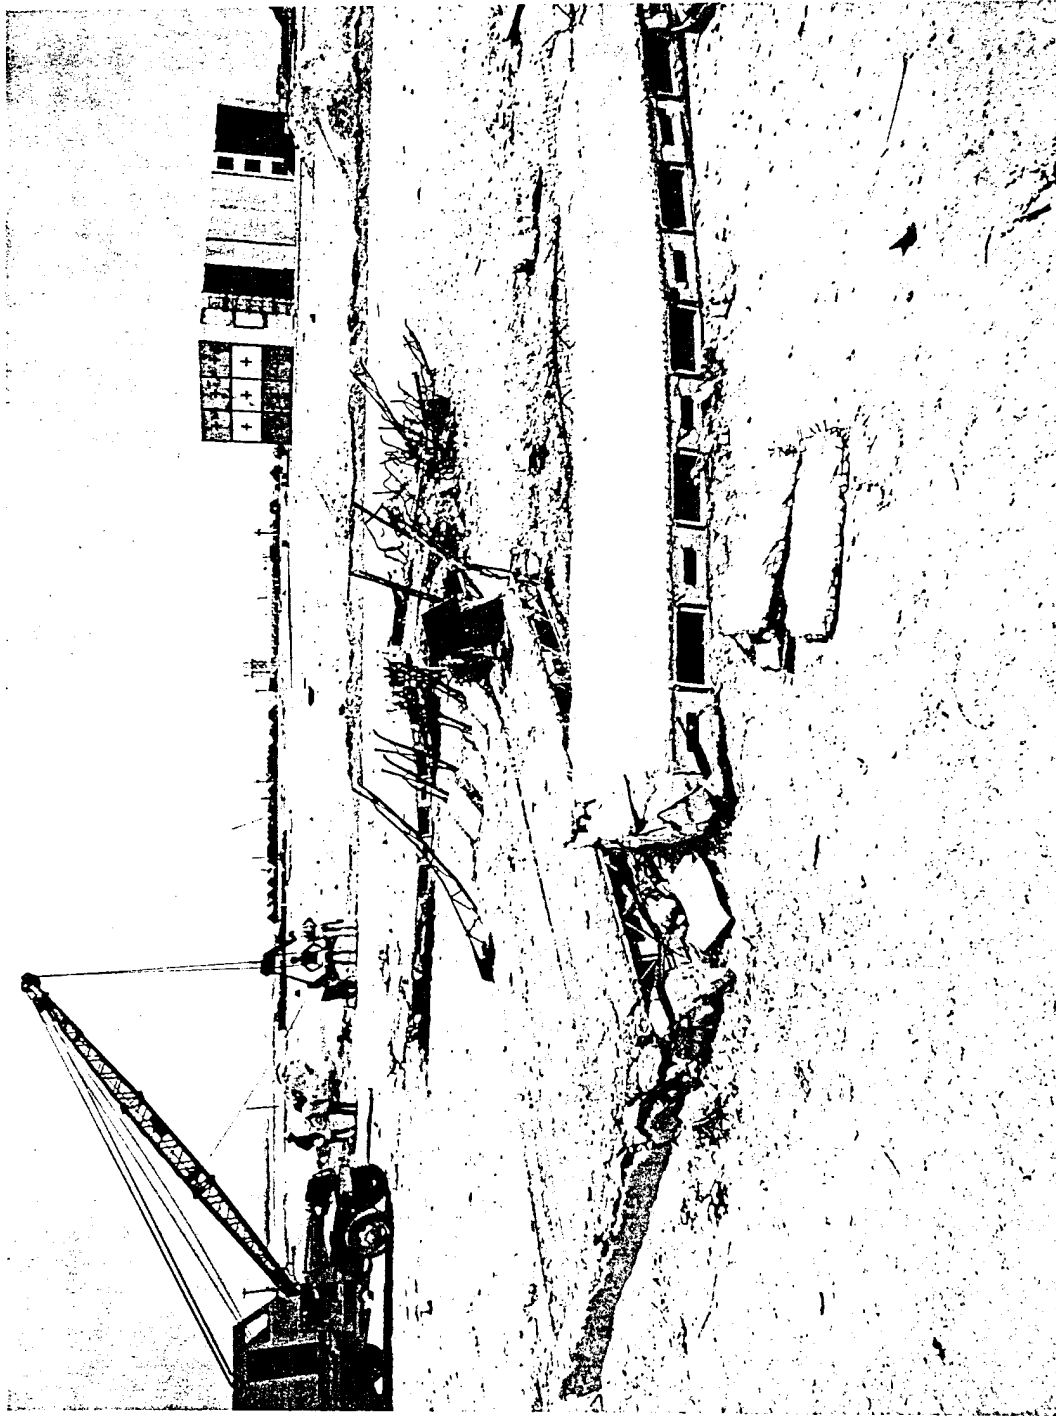
Fig. L. 256 General View of Roof Sections as They Landed after Being Hurlled about 75 ft, Structure 3. 2. 3b

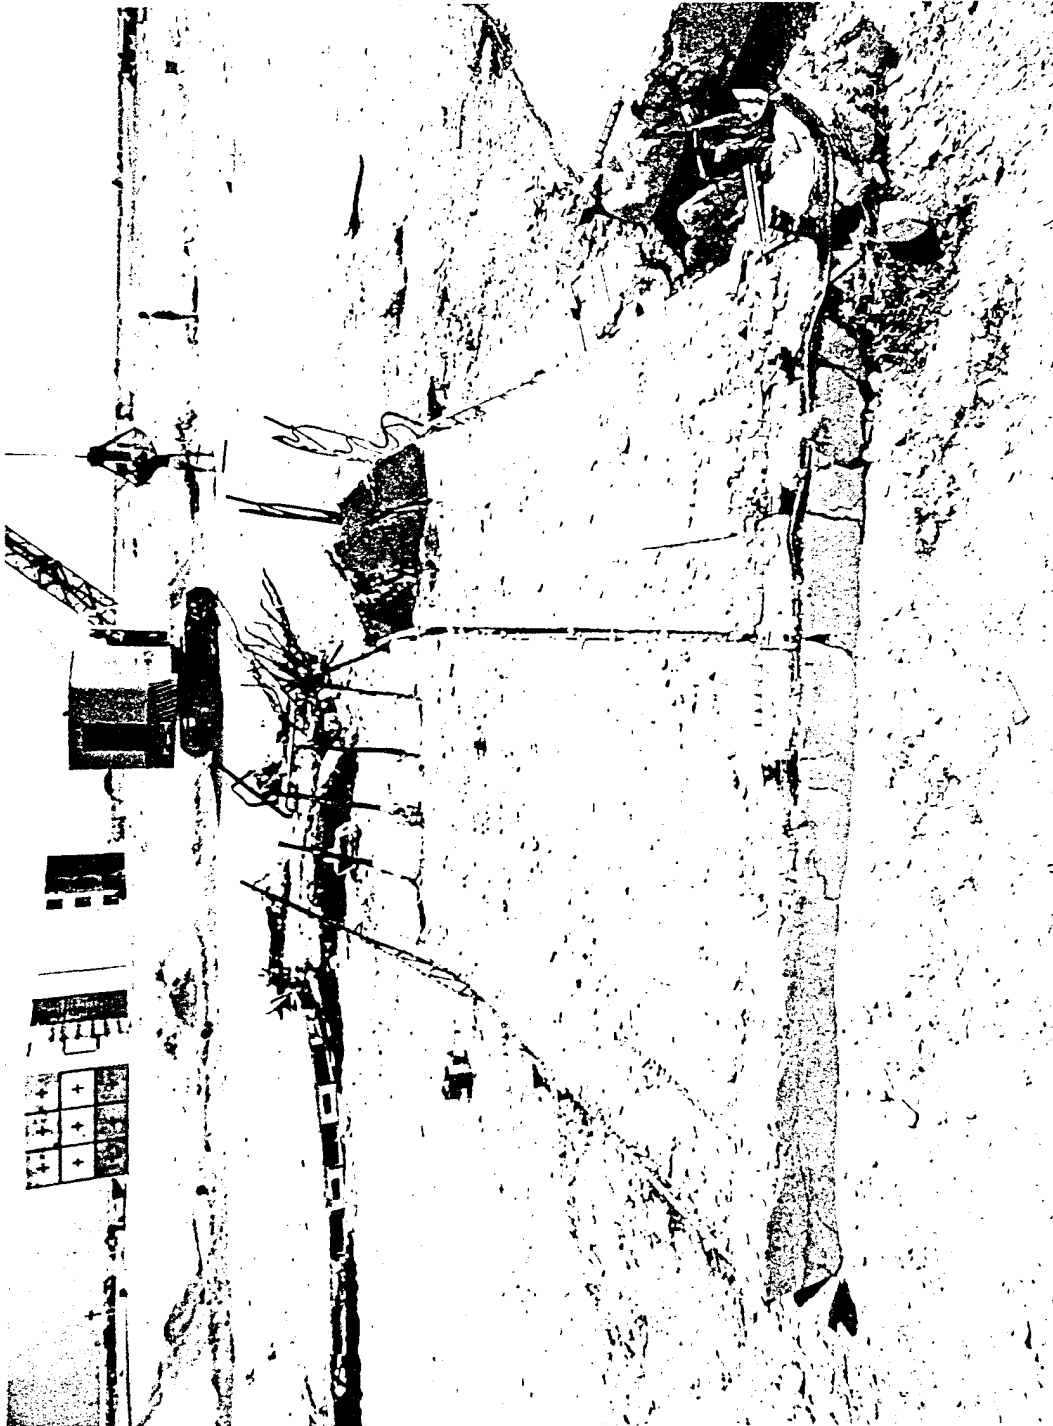
Fig. L.257 General View of the Left Half of Roof Section, Lying Upside Down, Structure 3.2.3b

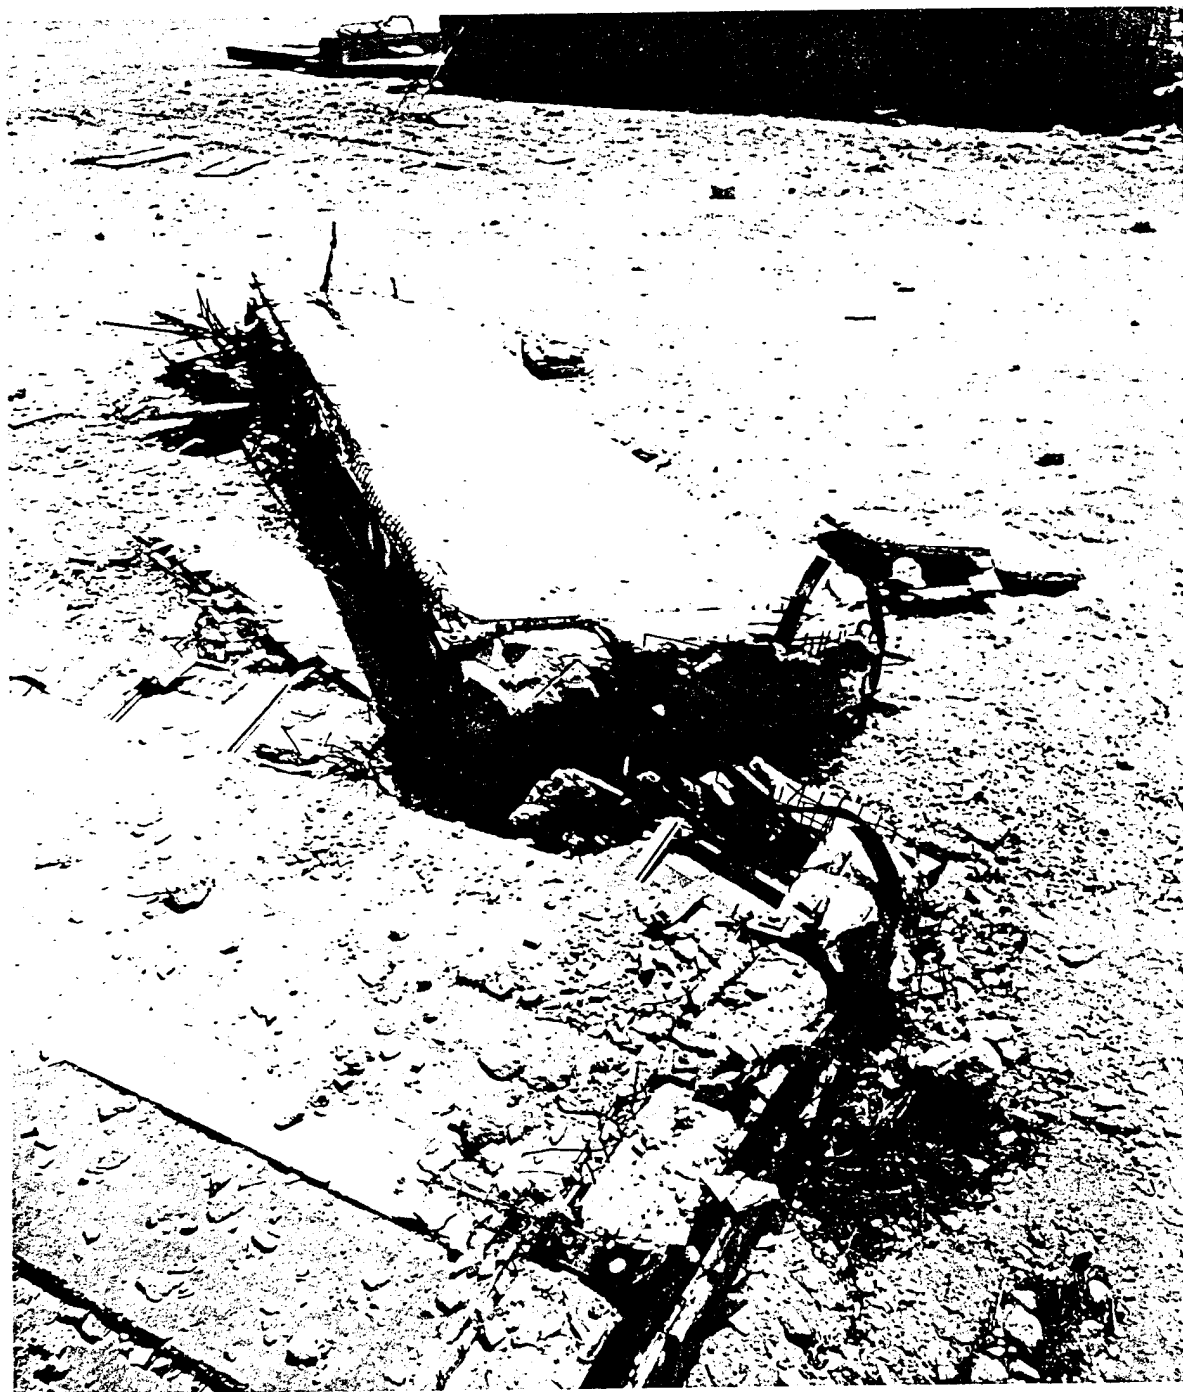
Fig. L.258 Detail View of Left Half of Roof Section, Structure 3.2.3b. Front edge of roof is in foreground.
